Draft Conservation Area Character Appraisal

East Hoathly

This document is the draft conservation area character appraisal for East Hoathly conservation area, designated in March 2017.

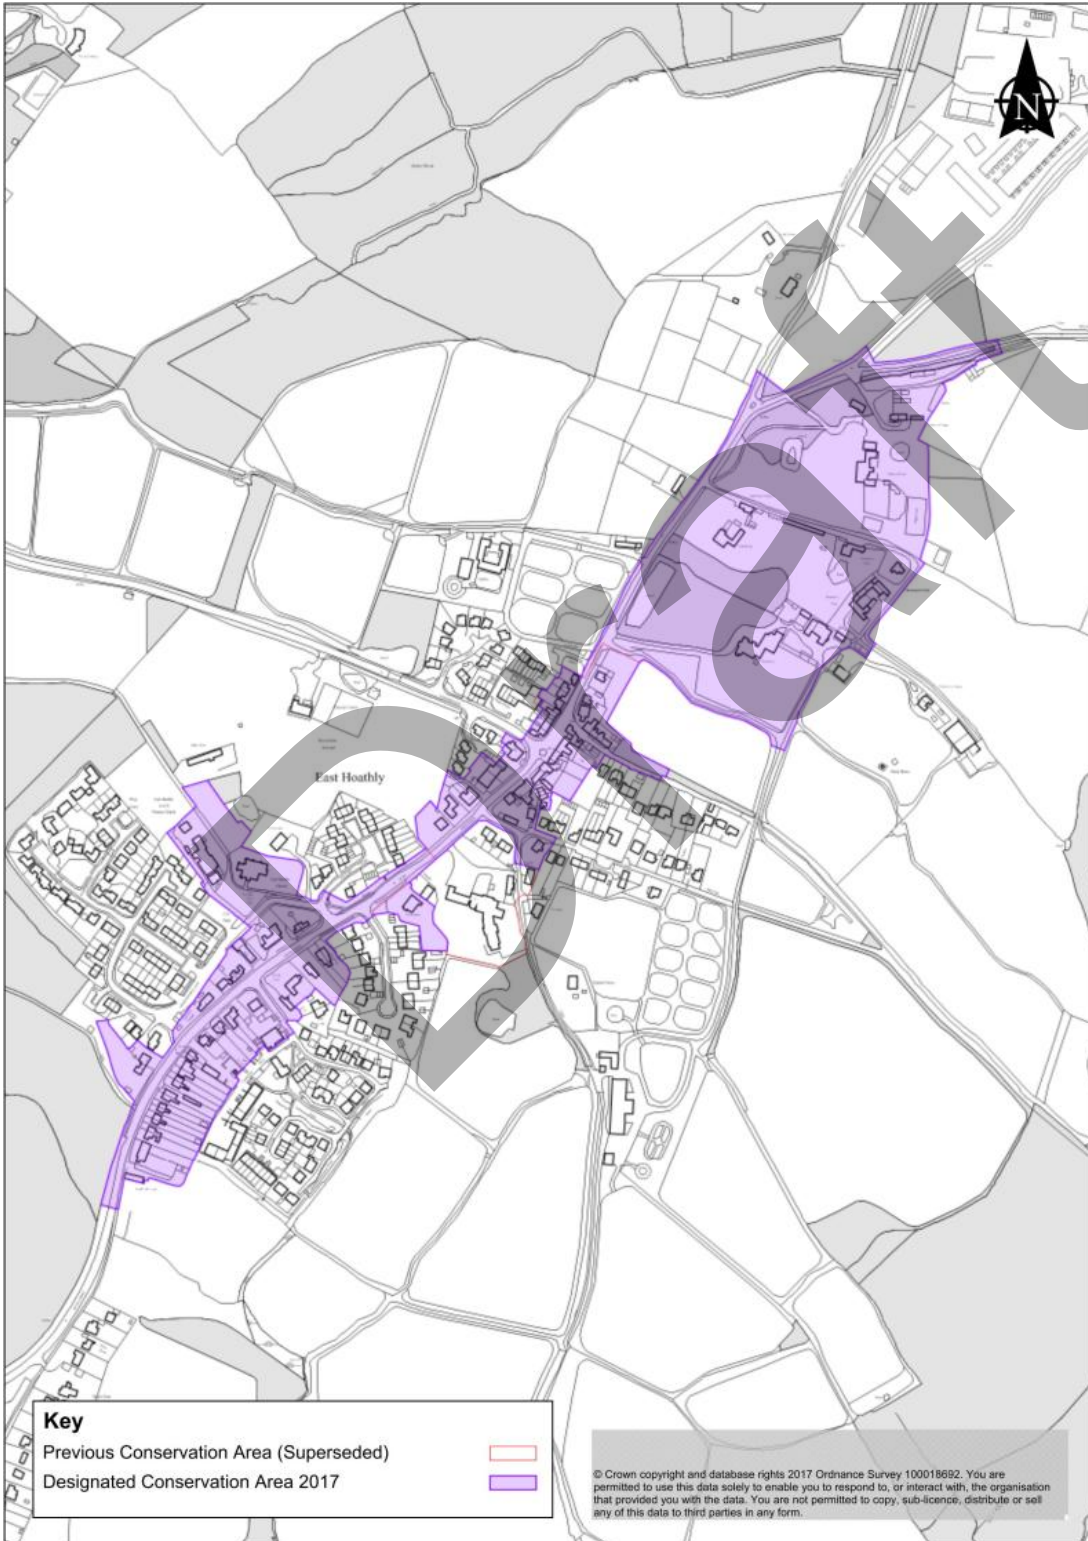
1.1 Designated Conservation Area

1.0.2 The designated boundary of the conservation area, detailed visual character appraisal map and views map are at Appendix 1.
